Research Article

Mechanical Properties of Full-Scale Prestressed Concrete Beams with Thin Slab after Exposure to Actual Fire

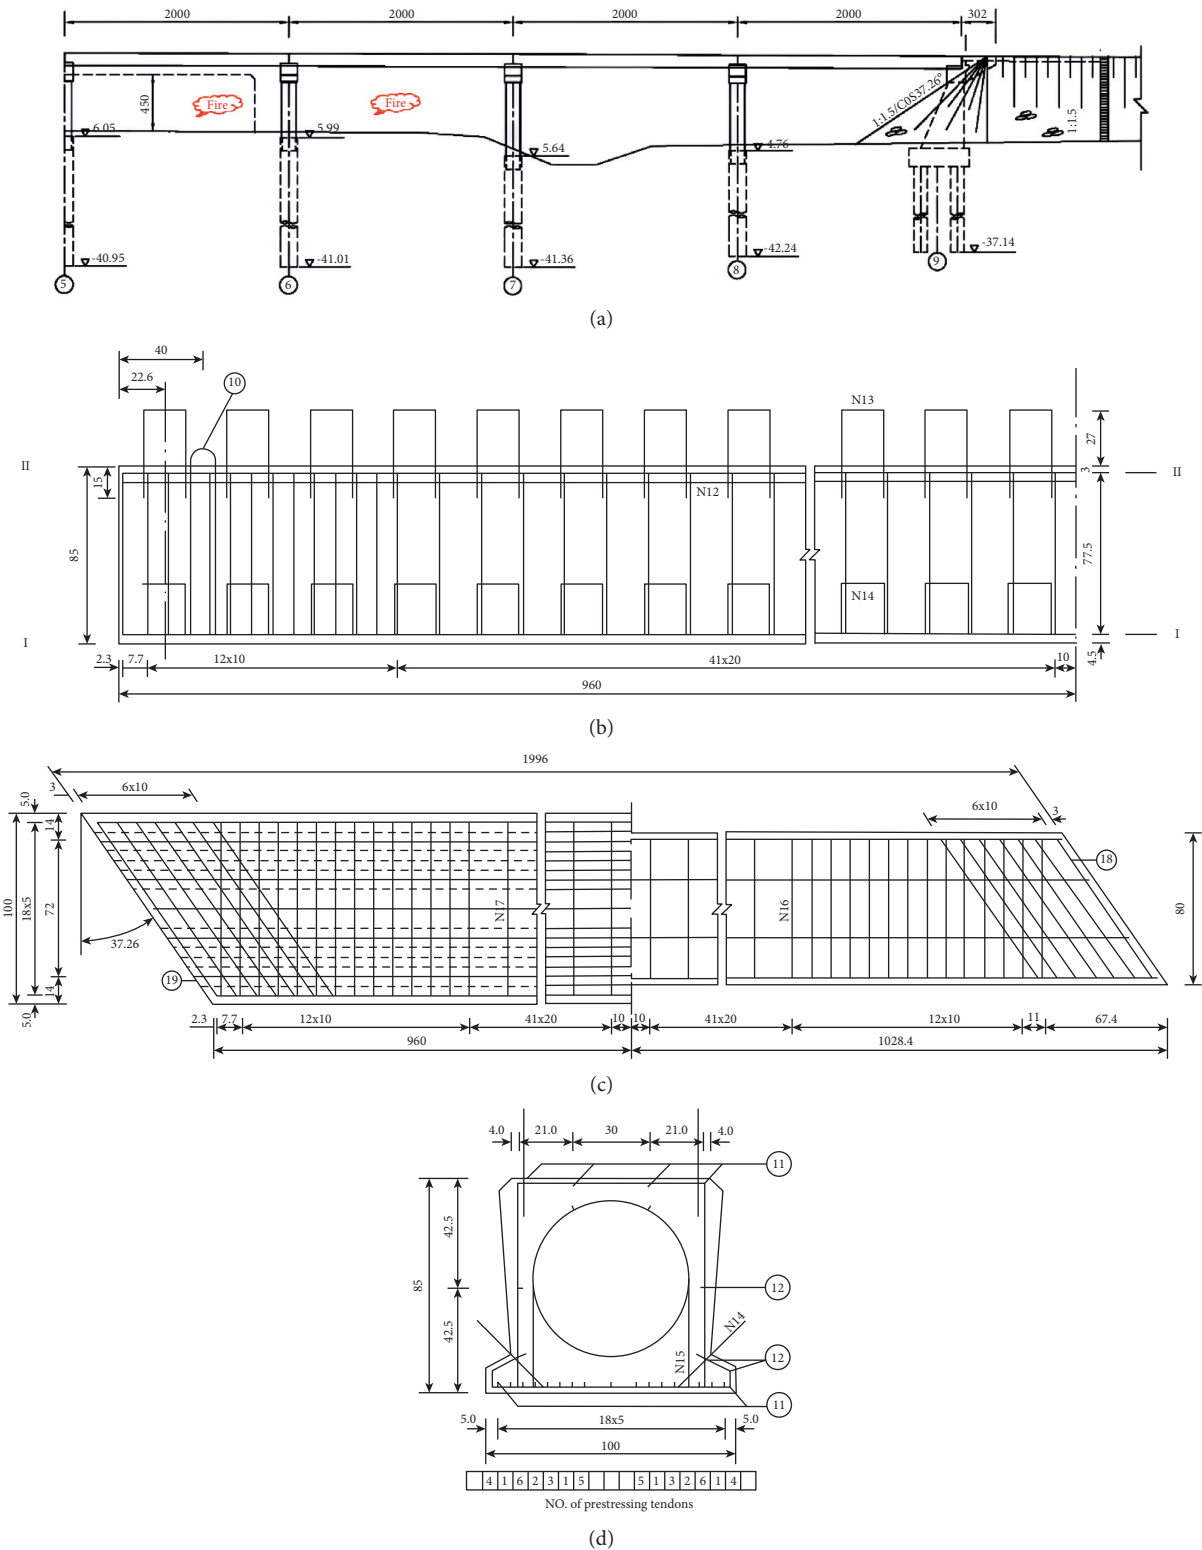
FIGURE 1: The elevation and reinforcement diagram. (a) Elevation (the unit of elevation is m, and the unit of span is cm). (b) Medium plate reinforcement diagram.

2.1. Source and Classification of Test Components. A precast 9×20 m prestressed concrete hollow bridge in-service on provincial expressway is designed in split width, and each width contains 16 hollow slab beams [15]. The minimum floor thickness of this bridge is 15 cm, the net protection layer thickness of steel strands is 3.6 cm, and the designed value of standard cube compressive strength of concrete is 50 MPa. Each middle beam of this bridge is equipped with 14 steel strands, and the effective length of these steel strands is shown in Table 1. Each prestressed steel bundle is composed of $6 \times \Phi_s 15.2$, whose standard tensile strength of prestressing tendons is 1860 MPa and the tension control stress is 1395 MPa. The reinforcement of elevation and middle plate are shown in Figure 1.

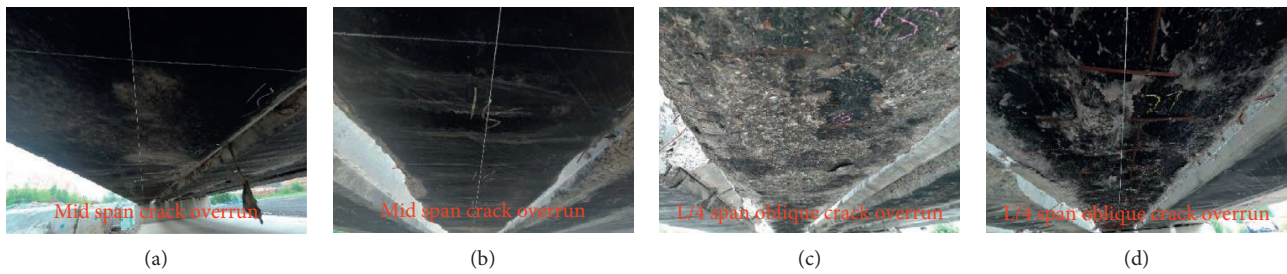
FIGURE 2: The appearance of test beam. (a) No. 2#. (b) No. 3#. (c) No. 4#. (d) No. 5#.

No.	The appearance of the floor (the floor is divided into 70 areas)
2#	The concrete was fumigated and blackened in partial areas without any other damage
3#	The color of the concrete remains unchanged. The sound of hammering in 6% of the concrete area is dull. 30% of the concrete area falls off with a characteristic depth of 2.1 cm, mostly locating at the end of the beam. And a small part of the beam-end steel strand is exposed, distributed from the fulcrum to quarter of the span
4#	6% of the concrete area is pink. Micro-crack and coarse-crack networks appear in partial areas. The sound of hammering in 76% of the concrete area is dull. 97% of the concrete area falls off with a characteristic depth of 2.6 cm. And the steel strands are exposed in some areas
5#	98% of the concrete area is pink or khaki. The sound of hammering in 96% of the concrete area is dull. 100% of the concrete area falls off with a characteristic depth of 3.6 cm. And steel strands in 25% of the concrete area have been exposed, which distributes from the fulcrum to a half of the span

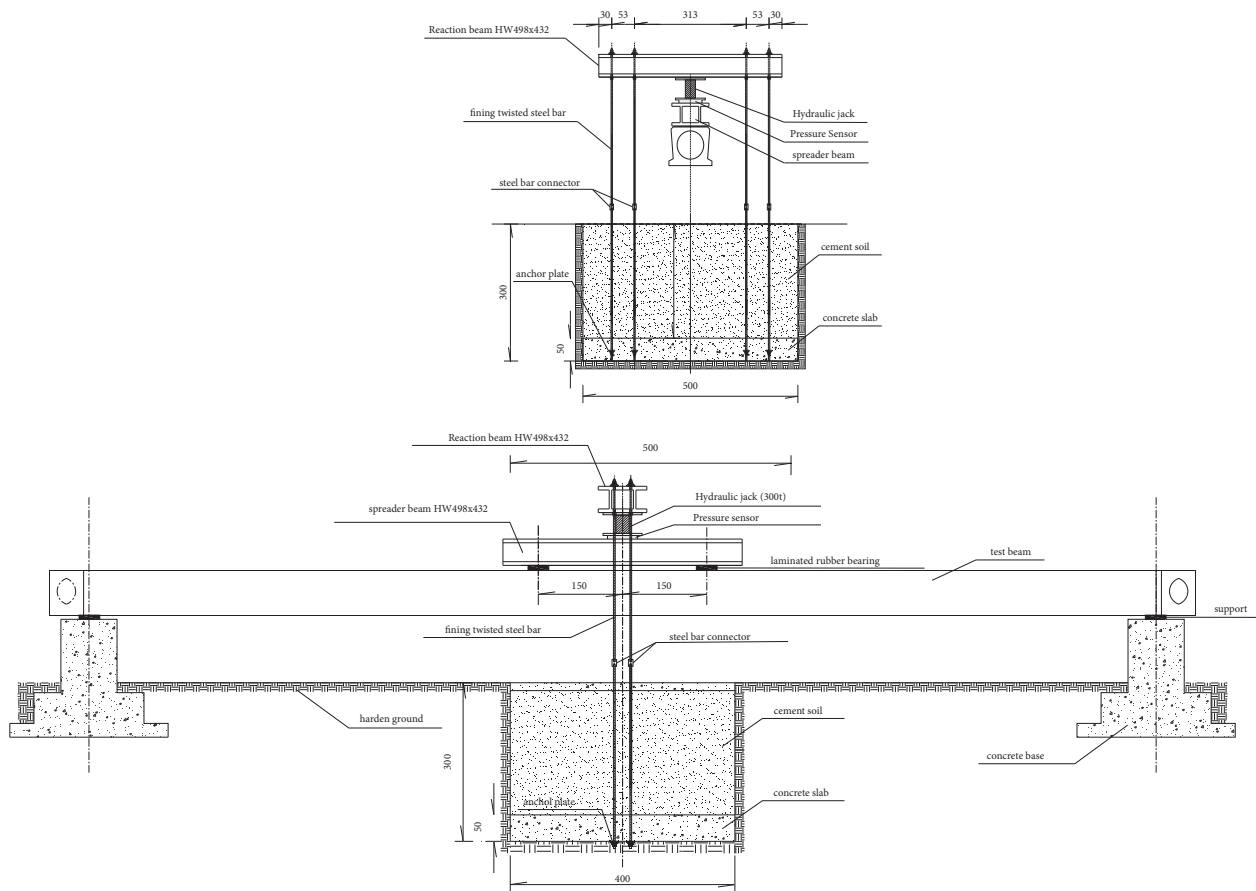
FIGURE 3: The loading arrangement (unit: cm).

2.2. Loading Device. Loading devices include ultra-high-pressure jack, rubber-bearing, welded H-type steel beam and counterforce beam, number display pressure ring, $\Phi 32$ fine-rolled rebar, and gravity ground anchor device. The pressure generated by the jack is applied to the longitudinal loading beam in the form of a reaction force through the ground anchor device. Then, the force is transferred from the longitudinal beam to the hollow slab structure through a rubber bearing (steel pad). The maximum bending moment in the normal section and the maximum shear force from one-third to two-thirds of the span length has been considered simultaneously in the test loading arrangement. The loading arrangement layout is detailed in Figure 3, and the on-site loading situation is shown in Figure 4.

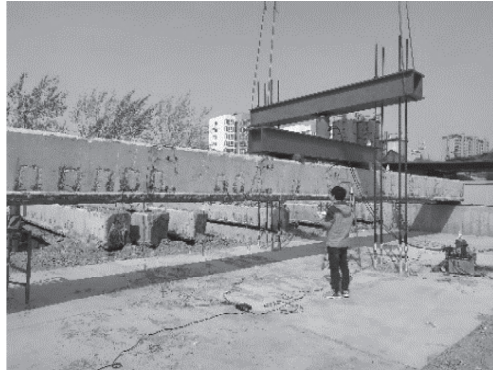
FIGURE 4: The on-site loading situation.

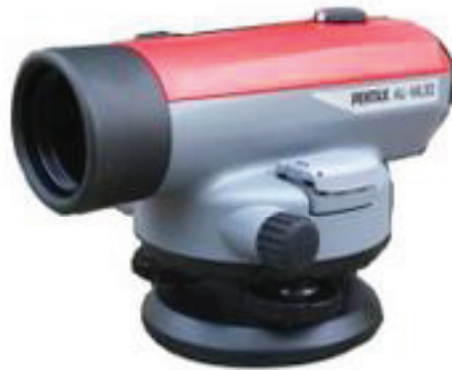
FIGURE 5: The AL-ML32 high-precision leveling instrument.

2.4.1. Beam Deflection and Pier Settlement Measurement. The deflection of the beam and the test bench under various loading conditions is measured by using AL-ML32 high-precision leveling instrument shown in Figure 5. Numbers of deflection and settlement at one-quarter of the span length, three-quarters of the span length, and the midspan can be read through the preembedded indium steel ruler.

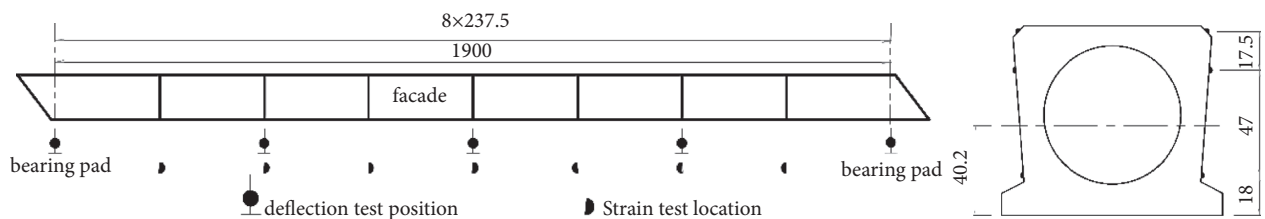
FIGURE 6: The strain location and deflection measuring points.

The detailed arrangement of measuring points is shown in Figure 6.

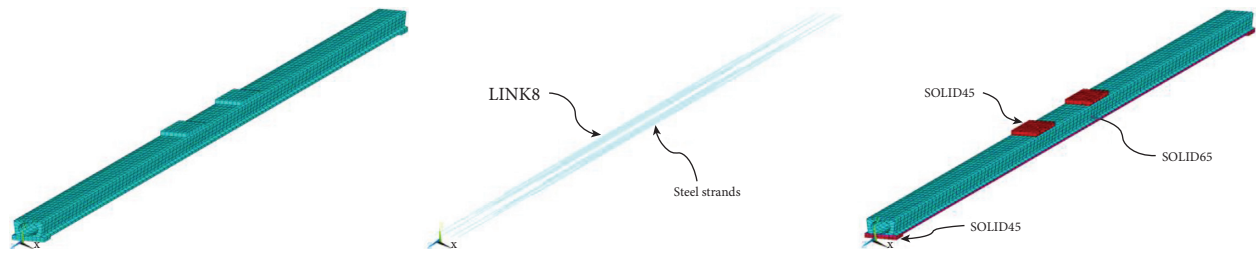
FIGURE 7: Finite element model.

2.5. Numerical Simulation. According to Chaowei et al. [15], after obtaining the material's mechanical performance parameters, the ultimate bearing capacity of the prestressed concrete beam was analyzed. And the finite element analysis method was applied during this process to meet the required engineering accuracy. The comparison between numerical simulation and the experiment proves that the beam 2# is almost unaffected by the fire and thus can be used as the reference beam [15]. The general large-scale finite element software ANSYS is used for modeling. SOLID65 elements should be selected for concrete. The stress-strain relationship model of concrete is an important part of the nonlinear analysis of after-fire concrete hollow slabs. And the dynamic hardening model is used for this simulation. In the concrete failure criterion, the shear-transfer coefficient of open cracks is set to 0.7 after trial calculations based on relevant experience, and the shear-transfer coefficient of closed cracks is set to 0.95. The uniaxial stress-strain of concrete can be found in [15]. Steel strands are simulated by the LINK8 unit, without considering the bond-slip between steel and concrete, and steel strands are simulated by the bilinear isotropic strengthening model BISO considering strengthening. To consider the exact effects, ordinary steel bars are dispersed into concrete elements in a way of defining real constants (reinforcement ratios of stirrups and longitudinal and transverse steel bars). In order to prevent stress concentration from causing the in-advance jumping out of the calculation, a unit with an elastic modulus 100 times that of concrete is set at the loading position and the bridge bearing. When dividing elements, a hexahedral mapping grid is used. The number of bridge elements is 5918 in total, and the number of nodes is 8266. The finite element model is shown in Figure 7.

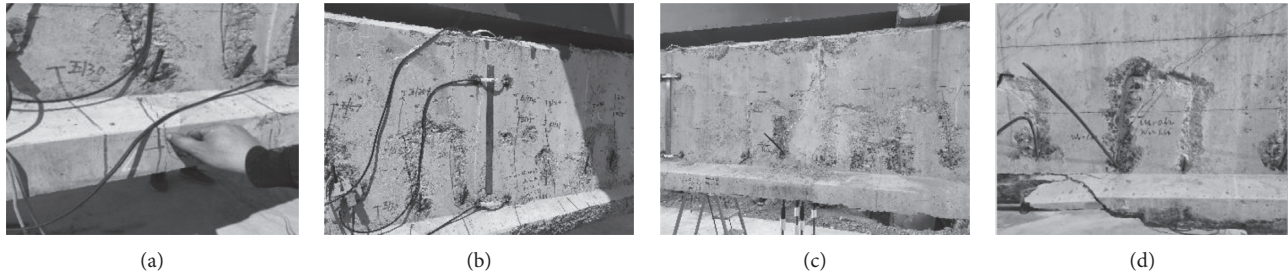
FIGURE 8: The typical failure pattern. (a) No. 2#. (b) No. 3#. (c) No. 4#. (d) No. 5#.

Cracks were spotted at the midspan where the longitudinal distance is 5.5 m. When these oblique cracks at the oblique cracks at the main tendon under tension firstly exceeded the vertical width of 1.5 mm, the loading was stopped. Typical failure mode is shown in Figure 8 and Table 4. It can be seen from the table that as the degree of beam damage increases, the failure mode of the test beam changes; that is, the shear failure will occur before the pure bending failure. The main reason was founded after careful considerations. As the fire temperature increases, the effective prestress of the bottom plate at one-quarter of the span length will decrease gradually, and the axial pressure that prevents the appearance and development of oblique cracks will decrease. Besides, due to the reduced strength of steel strands and concrete materials, the damage mode of such beams finally changes.

Beam no.	Failure form
2#	The cracks in the tensioned main steel bars near the middle of the span first exceed the width of 1 mm
3#	The cracks in the tensioned main steel bars near the middle of the span first exceed the width of 1 mm
4#	The width of the crack at the tensioned main steel bar at the diagonal crack near 6.5 m from the middle span exceeds 1 mm
5#	The width of the crack at the tensioned main steel bar at the diagonal crack near 5.5 m from the middle span exceeds 1 mm

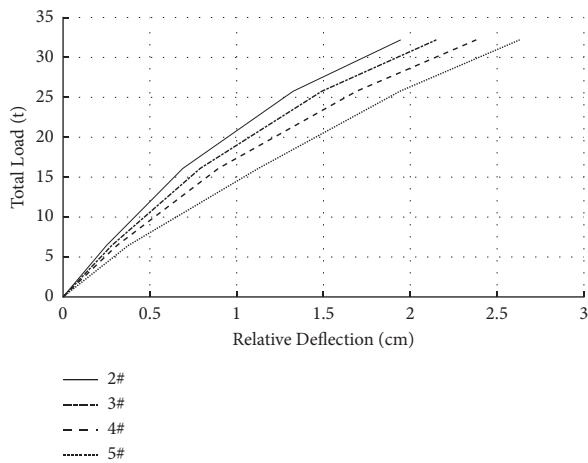
FIGURE 9: Midspan deflection-load curve of normal loading.

4.1.1. Normal Loaded Displacement. The normal-loaded deflection-load curve of midspan is shown in Figure 9. From the figure, the displacement-load relationship of the beam 2#, beam 3#, and beam 4# is linear when the total load distributes from 0 to 16 tons (just call it “0–16t stage” in the following passage). The displacement-load of the beam 4# in the “0–8t stage” is linear. In the “15~32t” stage, the measured stiffness of the hollow slab beam 2#, 3#, and 4# has decreased, and the downward deflection value of the midspan has accelerated. In the “5~32t” stage, the stiffness of the hollow slab beam 4# has decreased. While before the “5t stage,” the reduction of the stiffness was obvious but not too sharp during the loading process.

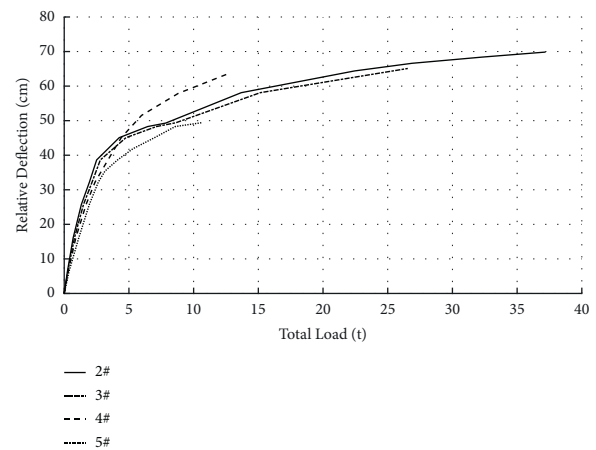
FIGURE 10: Deflection-load curves of beam 2# and beam 5# in midspan.

The ultimate load results are summarized in Table 6 and Figure 10. From the table, the ultimate bending moments of beams 2#, 3#, 4#, and 5# are reduced successively. And the ultimate bending moment of beam 5# is only 76.4% compared to beams not exposed to fire, which is reduced by 23.6%. The corresponding deflection values of the limit bending moment of beams 2#, 3#, 4#, and 5# are gradually increased. Consequently, as the fire damage becomes more and more serious, the ultimate damage mode gradually changes from ductile failure to brittle failure, especially for beam 5#. The ultimate failure deflection of beam 5# after the fire is only 28.5% of that before the fire.

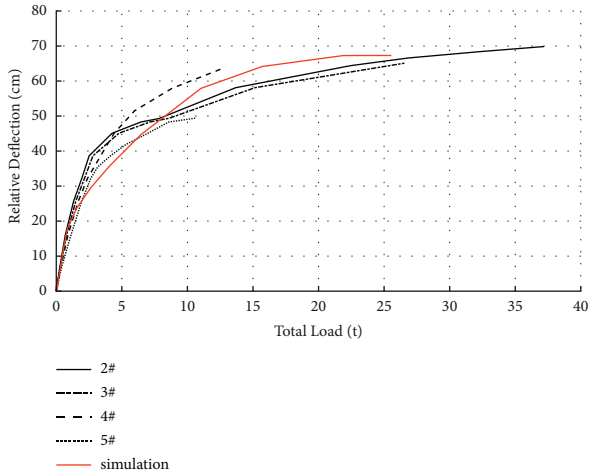
FIGURE 11: Contrast diagram of midspan deflection (simulated value of beam 2# and the unfired beam).

Figure 11 is the contrast diagram of finite element simulation values between beam 2# and the unfired beam. The midspan deflection of beam 2# was almost equal to the

simulated value before cracking. And there is only a slight difference of the deflection before and after cracking, which can furtherly prove that beam 2# is unaffected by the fire and can be used as the reference beam. The mechanical properties of concrete and steel reinforcement materials will decrease to varying degrees after a bridge fire. The reduction coefficient of concrete compressive strength after natural cooling is only 0.8 times of the strength before the fire, when the overfire temperature exceeds 300°C [18, 19]. The strength reduction coefficient grows when the overfire temperature increases. And that coefficient reaches 0.2 under an overfire temperature beyond 800°C. Fire will cause the yield strength of the steel bar to decrease after cooling, but its reduction coefficient is less than that of concrete under the same overfire temperature. And that coefficient is 0.95 at around 400°C (which is the overfire temperature). After high temperature, the yield strength of prestressed steel bars has a certain relationship with the highest temperature and the initial stress level [20]. The ultimate strength and yield strength generally decrease with the increase of temperature. Also, the fire not only causes the physical properties of steel bars and steel strands to decrease, but also reduces the bonding force between them and its wrapping concrete [21]. As the overfire temperature increases, the concrete spalling becomes more serious, and the effective stress of the steel strands is distributed more unevenly along the longitudinal direction [22, 23]. With the gradual increase of the load, this phenomenon becomes far more obvious, which will cause the steel bar (steel strand) to yield before the concrete compression crashing. And the phenomenon is quite similar to the failure of under-reinforced beams. The following test results of full-scale compressive strain and diagrams of crack distribution can furtherly prove it. (1) When beam 2# fails, the cracks that appeared are relatively short and dense. The crack spacing and the average width of beam 2# is much smaller than that of beam 5#. (2) The compressive strain exceeds 0.002 for beam 2#, being 0.0008 for beam 5# when fails. Based

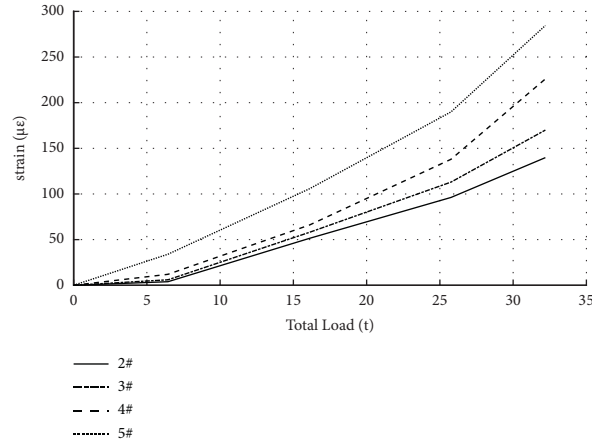
FIGURE 12: Strain history of normal loading tension side (measuring points 4-6#).

4.2.1. Normal Load Strain. The normal loading strain results are shown in Tables 7 and 8 and Figures 12 and 13. From the figure, at the preliminary stage of loading (when the total loading weight is less than 7t), the strain-load relationship is linear. The tensile test concrete strain-load curve is obviously nonlinear when loading weight is bigger than 7t, indicating that invisible microcracks on the tensile side will gradually appear at the middle and late loading process. At the last loading process, when the total loading weight is 32.2t, the strain on the tension side of beams 2#, 3#, 4#, and 5# gradually increases. In other words, the strength of beams 2#, 3#, 4#, and 5# decrease in sequence. After unloading, the residual strains of all selected beams are less than 20%.

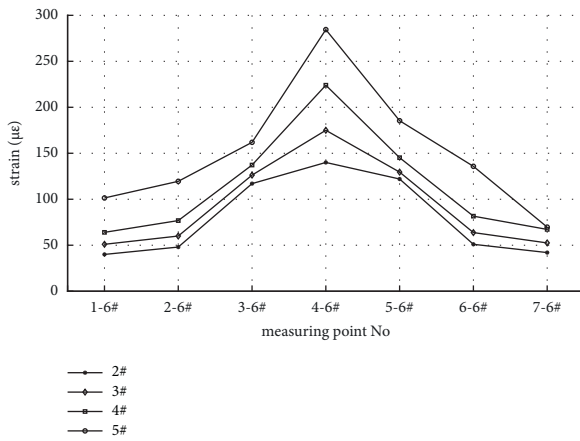
FIGURE 13: Strain distribution diagram of each section (tension side).

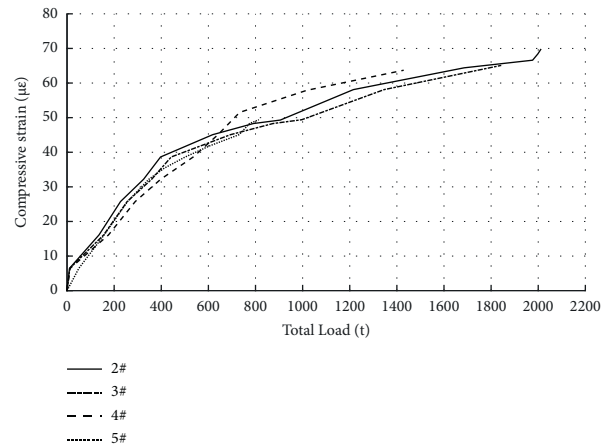
FIGURE 14: Strain distribution of typical beam section (tension side).

814 $\mu\epsilon$. And the strength of concrete materials is far from being fully utilized. The strain loading history of concrete on the compression side of a typical beam is shown in Figure 14.
