Repair of Pre-Cracked RC Beams Using Several Cementitious Materials

Samir M. Shihada^{1*} and Yasser M. Oida²

Research Article

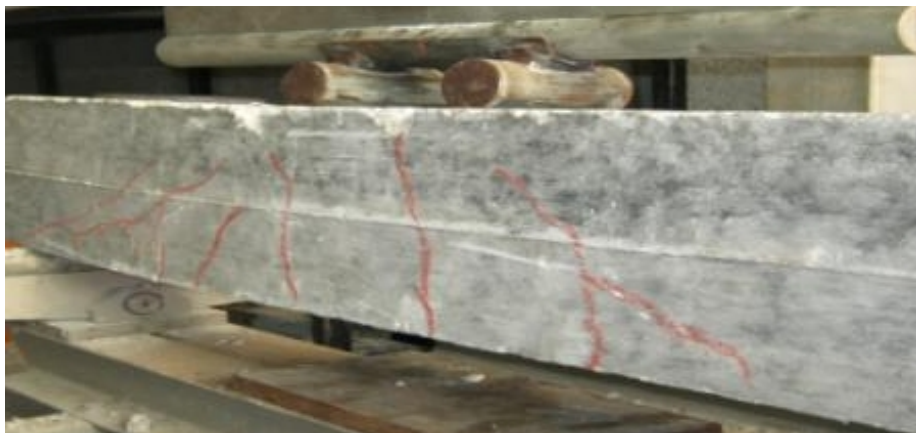
Fig. 2. Pre-cracks are marked

Twelve beams are tested in a loading frame under four point-loading to two thirds of their ultimate load capacities in order to induce initial cracks and be ready for application of the repair materials, Fig. 2. The cracks are then grooved to form a V-shape using a chisel in order to replace the damaged concrete for widths ranging from 2-3 cm at the extreme tension fiber to zero width around the tension reinforcement level. Then, water is sprinkled on the formed groves to remove any loose materials, Fig. 3.

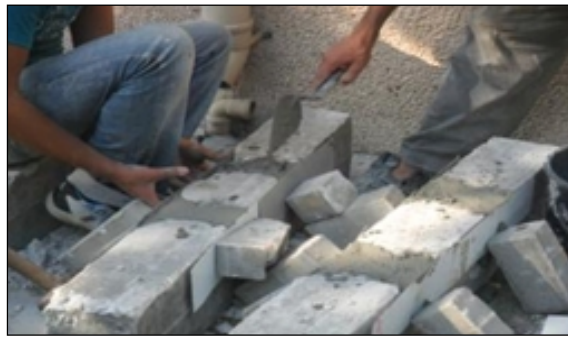
Fig. 4. Cracked beams after application of the repair materials

Four beam groups (3 beams each) are then repaired using the four repair materials and wet cured for another 7 days, Fig. 4.

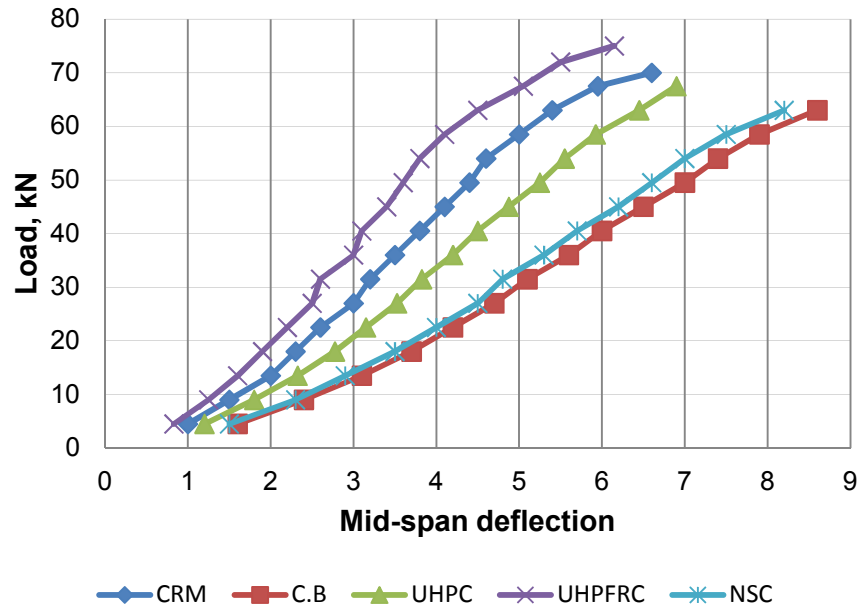
Fig. 6. Load vs. mid-span deflection

The repaired beams, with no exception, show less mid-span deflections than the control beams. This may be attributed to the increase in stiffness of the repaired beams (increase in their moduli of elasticity). The least deflection values are obtained from the beams repaired using UHPFRC and CRM, as shown in Table 2 and Fig. 6.

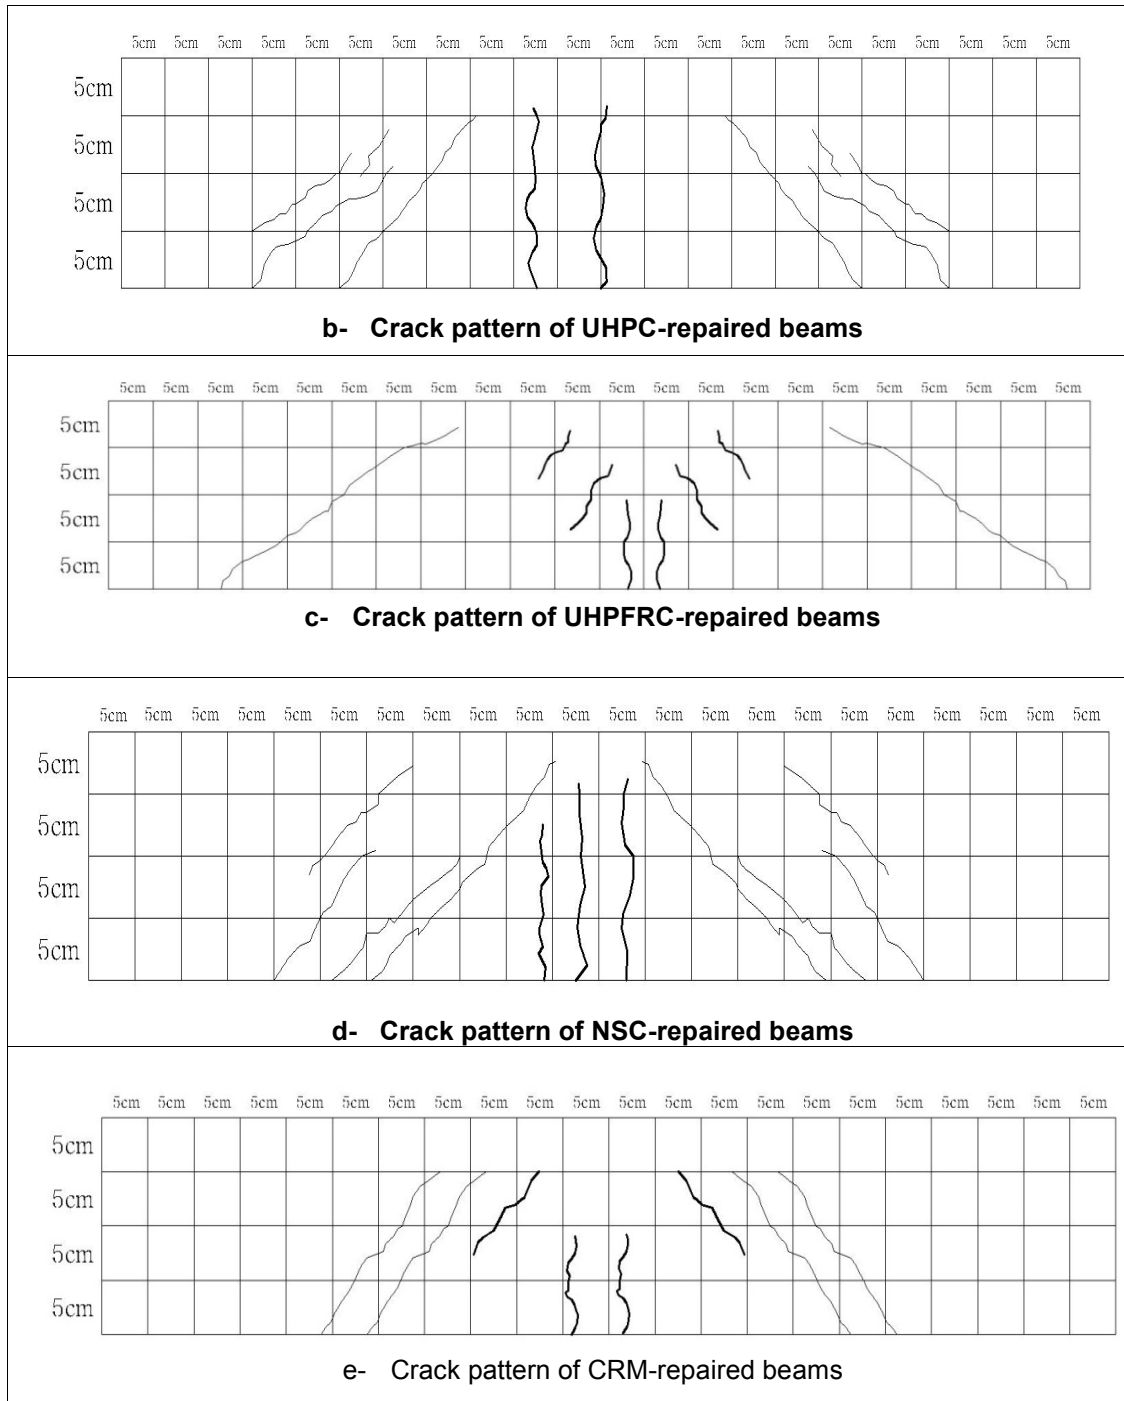
Fig. 7. Crack patterns of all of the tested beams

The crack patterns of the repaired beams are flexural cracks outside the repair area. The beams repaired using UHPFRC and CRM showed less crack widths and lengths compared to the beams repaired using UHPC and NSC. Furthermore, web shear cracks are more significant for the repaired beams, which proves the effectiveness of the adopted repair technique in general, Fig. 7.

- It is recommended to use UHPFRC or CRM "BETONREP-250" for repair of beams damaged in the form of excessive cracking.
- Smaller mid-span deflections are recorded when UHPFRC and CRM repair materials are used.
- The crack patterns of the beams repaired using UHPFRC and CRM show less flexural cracks compared with the rest of the beams.
- It is not recommended to use NSC in repair of damaged beams.
- Future investigations are needed in order to assess the performance of repaired beams when submitted to blast loads.
